City of Hawthorne

Municipal Sewer System Master Plan

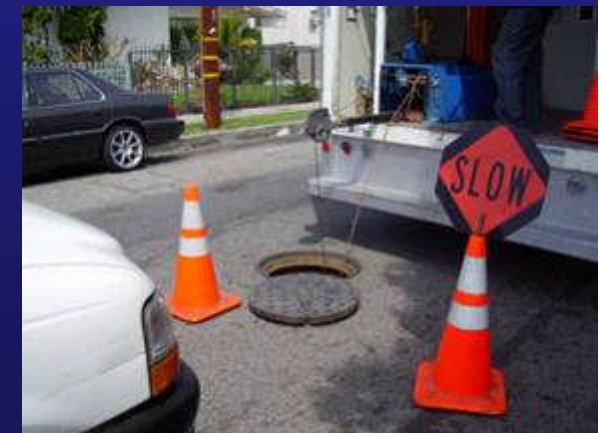
MH D7-46
CORDARY AVE.

1.8 FT
General Photo

8" inch VCP
02/13/2007

MH D7-45
CORDARY AVE.

151.0 FT
Tap Factory Active
3 O.Clock

Remarks W/ ROOTS MEDIUM

MH E7-48
144TH ST.

128.2 FT
Hole Soil Visible
9 O.Clock

Remarks IN TFA

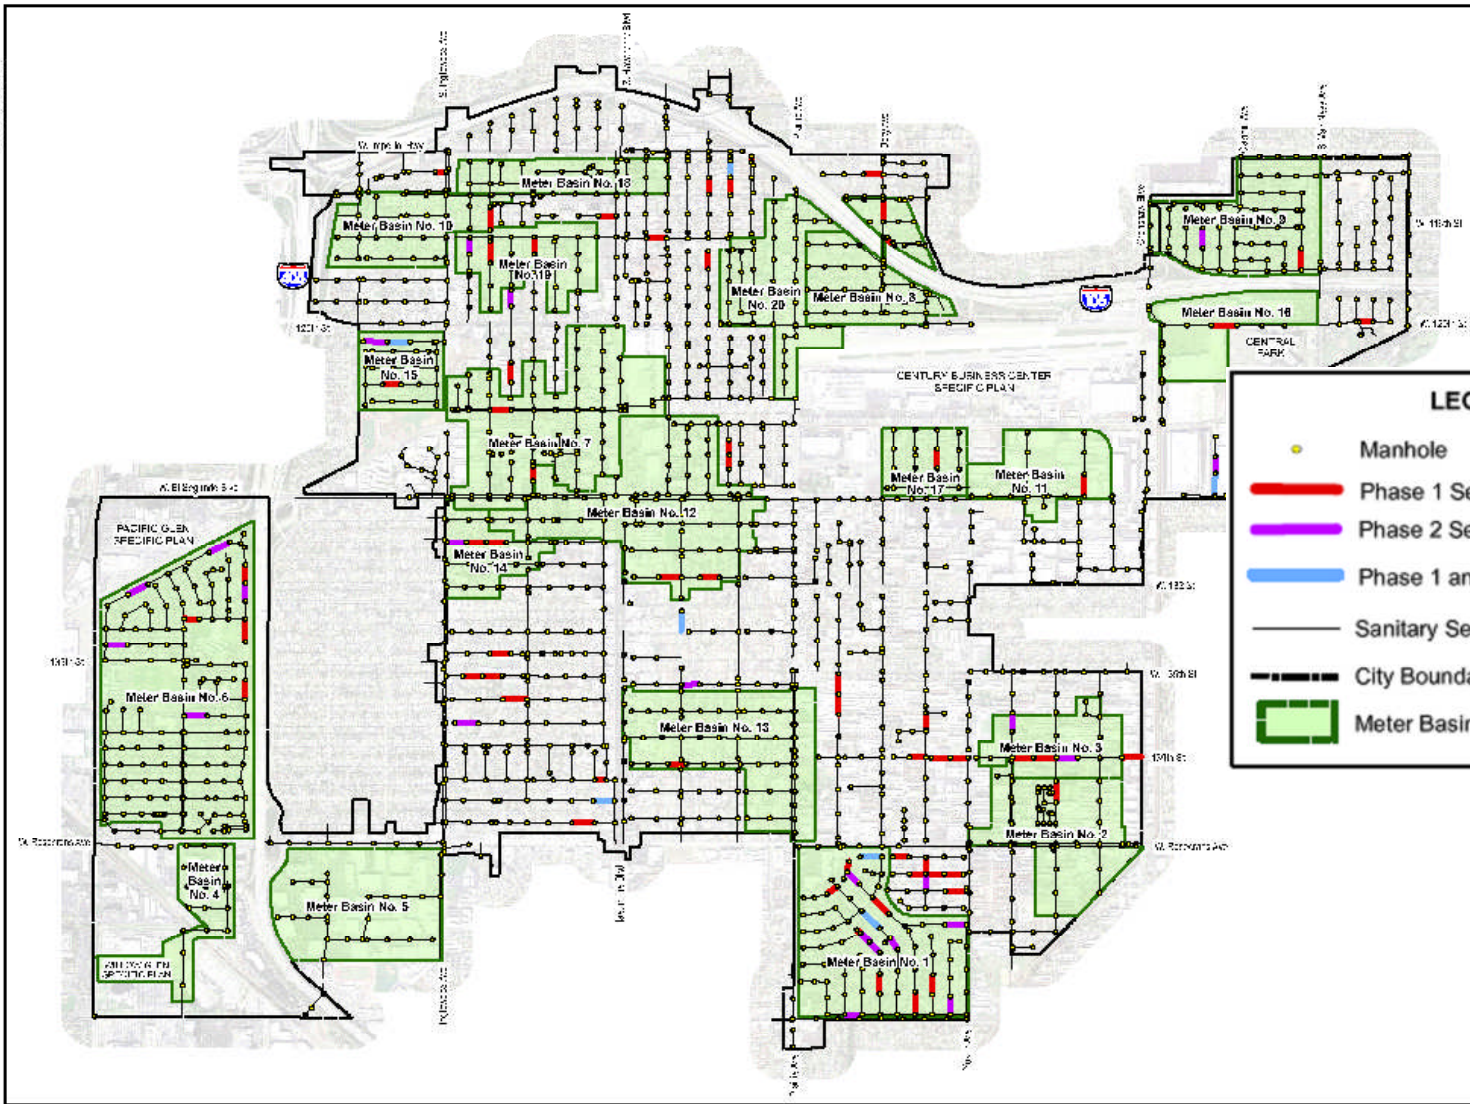
Figure 6-2
Recommended Sewer Improvement Projects

- 4 miles of sewers need improvements in Phase 1 and 2 miles need Phase 2 improvements
- Of 400 manholes, 28 had a structural defect such as wall cracking
- Phase 1 projects are scheduled to occur within the next 5 years to correct the most severe defects
- Phase 2 projects are scheduled to occur within the following 5 years (years 6 -10)
