City of Hawthorne

Municipal Sewer System Master Plan

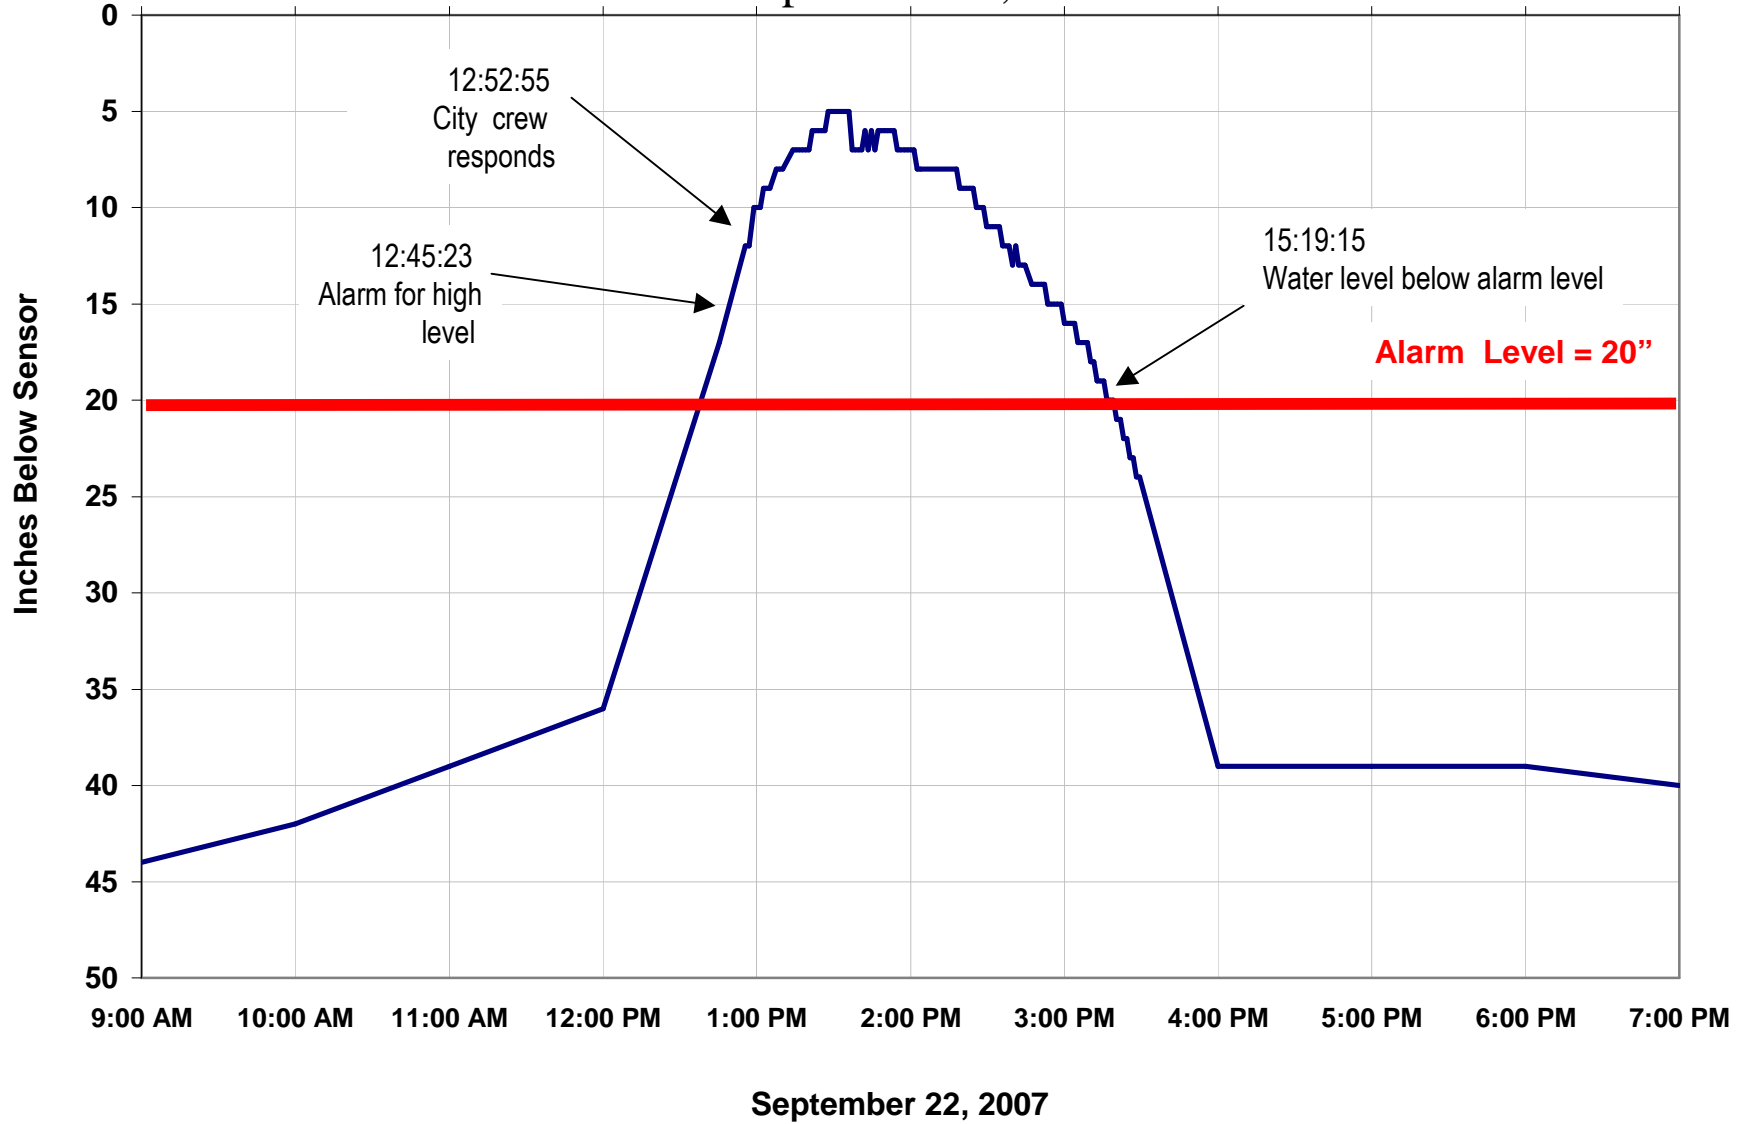
Water Level History During Rain Event
SmartCover® Location: 116th and Birch
September 22, 2007

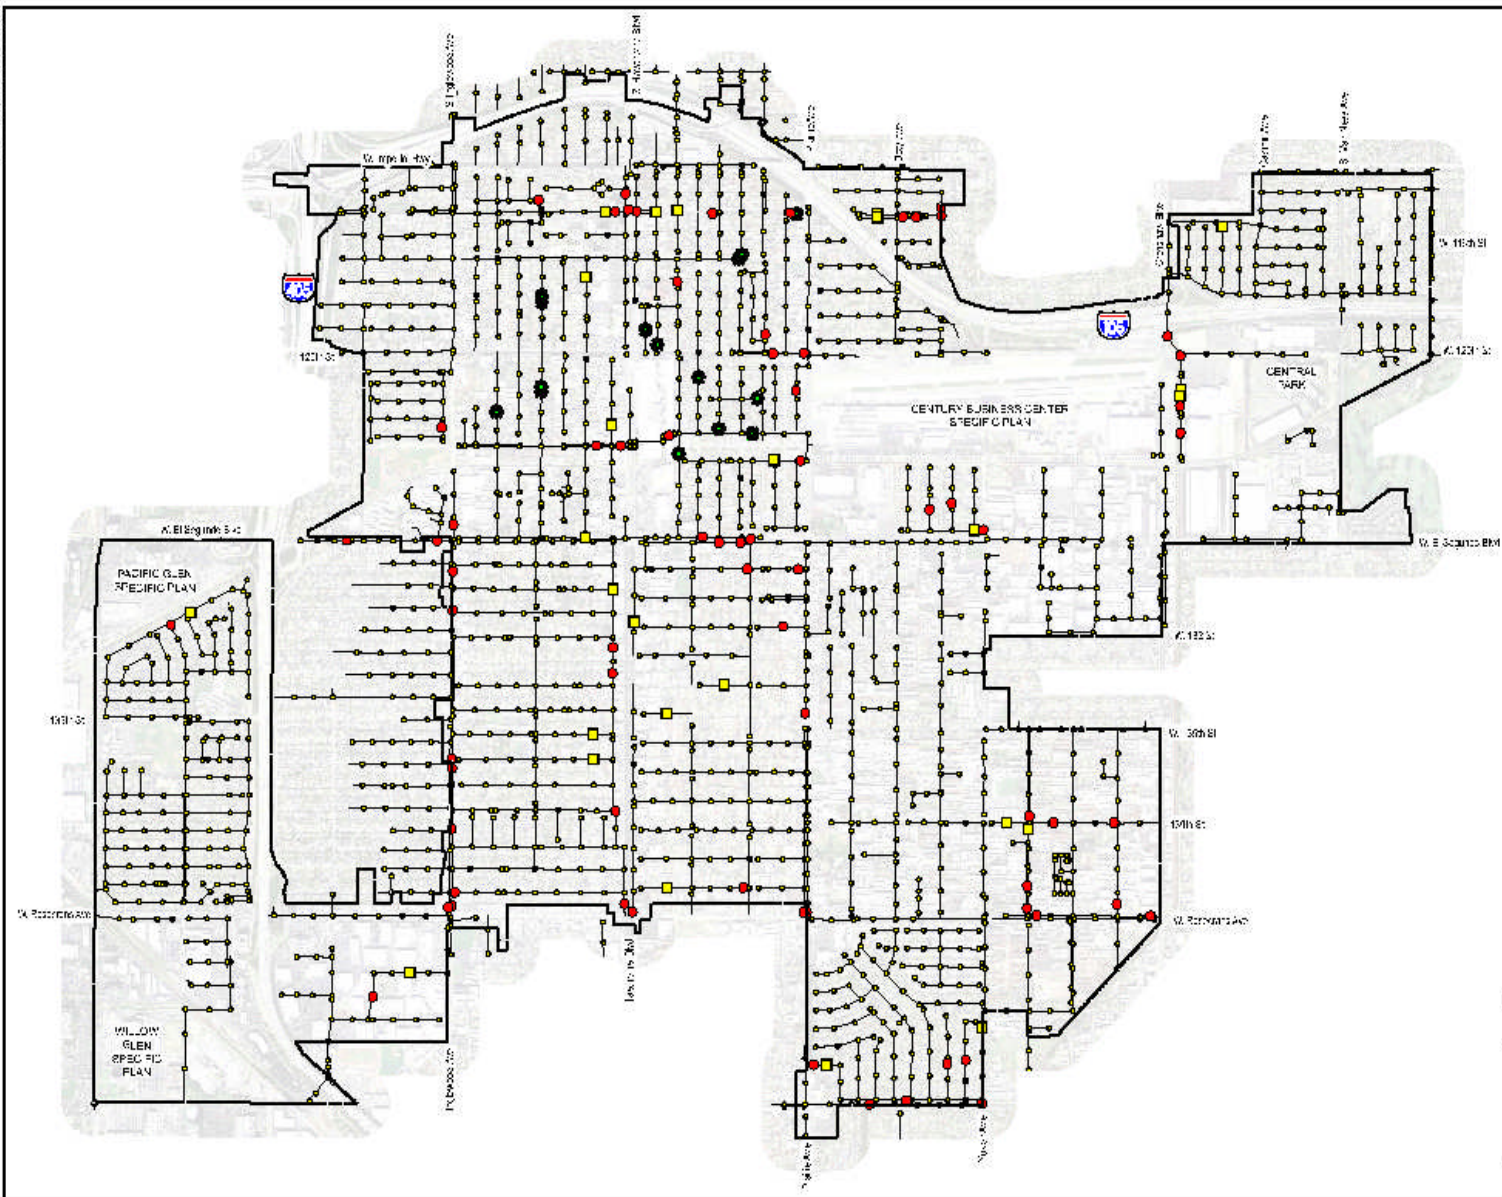
- 90 miles of sewers ranging from 4 to 18 inches in diameter and over 2,000 manholes in system
- Some sewers date back to 1920s but most constructed in 1950s
- “Hot Spots” are locations in system that can have heavier root and grease buildups
- City continuously monitors hot spot areas via smart covers and clean these sewers more often

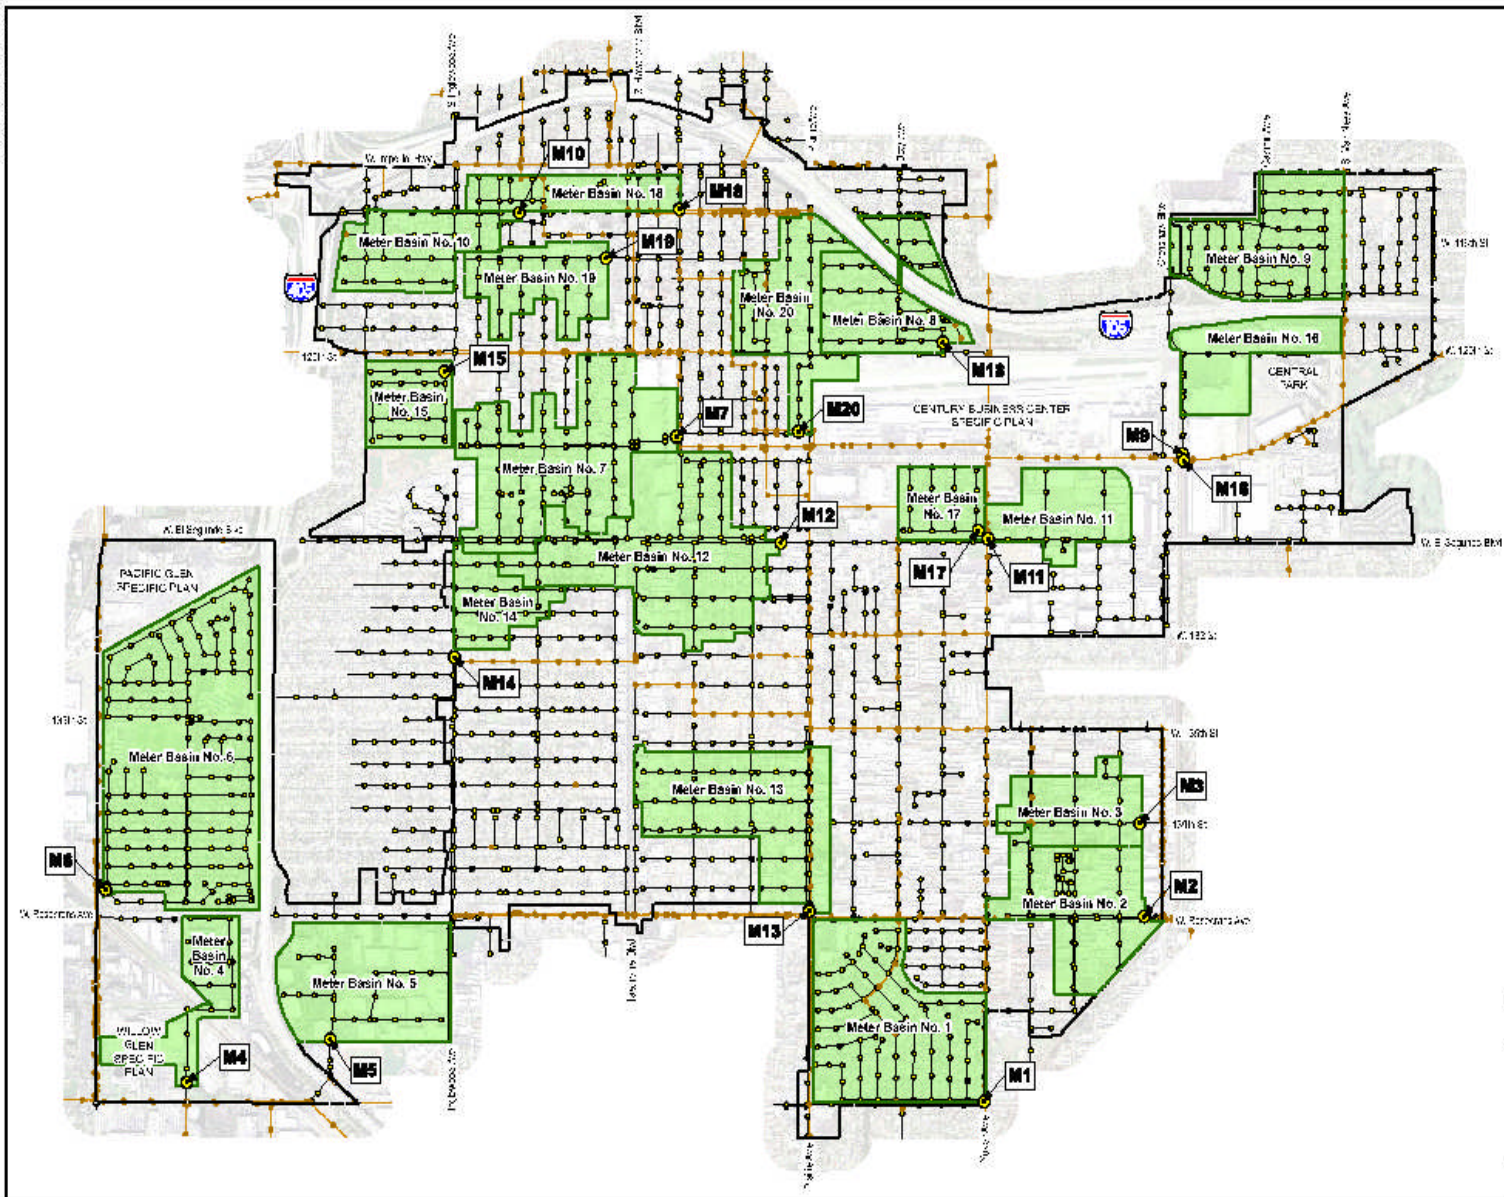
CITY OF HAWTHORNE
Figure 4-1
Municipal Sewer System
Master Plan
**Flow Meter Locations/
 Metered Areas**

- Flows in 20 areas (basins) of City metered for 30 days in February 2007
- Dry weather flow patterns determined
- Metered in February in order to capture rain, which can enter system and cause overflows
- Rain water enters system via manhole and sewer openings. Sewer system defects such as broken pipe and manholes located in drainage areas let in more water
